# Manhole Inspection Summary

Manhole # S13OO1009MH

**Location** Address: **4817 LAUREL AVE**

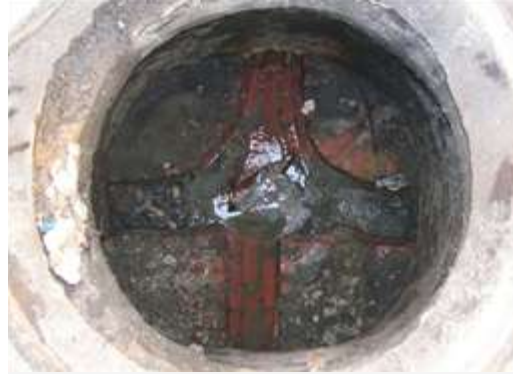
Top View

Evidence of surcharge - Bench debris.  
Channel debris.

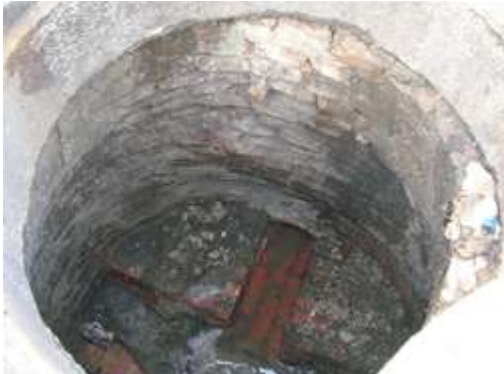
Defect

Frame leaks. Frame offset. Adjustment deterioration, loose brick and infiltration. Corbel and Barrel infiltration - other side.

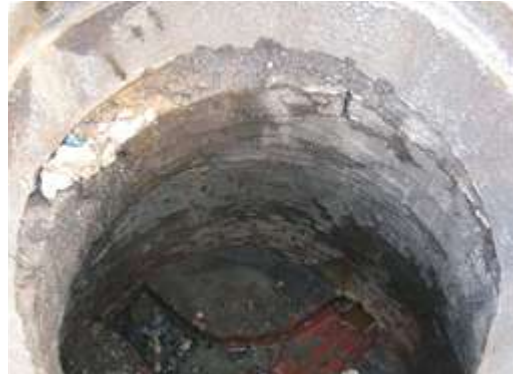
Defect

Frame leaks. Frame offset. Adjustment deterioration, loose brick and infiltration. Corbel and Barrel infiltration.

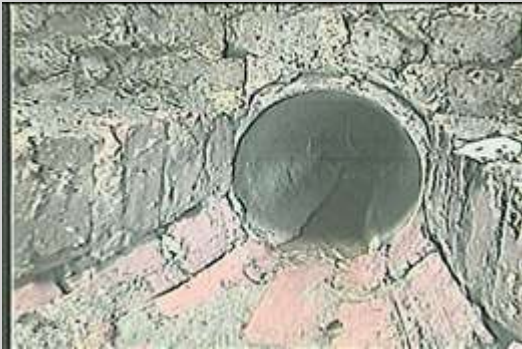
### 8 in. Circular Gravity Sewer Pipe Out @ 12 O'Clock

Barrel deterioration and infiltration. Channel deterioration.

Infiltration: **None** Pipe Seal Cond: **Cracked**

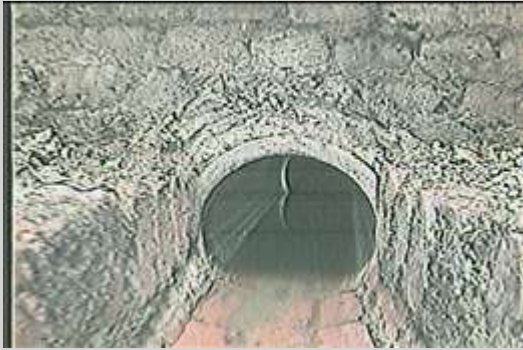
Pipe In @ 6 O'Clock

Deposits: ☐ None ☐ Mud ☐ Sludge ☐ Debris ☒ Grease

Silt Depth: **0** (in.) Deposits Extent: **Light**
